JK 4 OIL SPILL REPORT

THE GROUNDWORK PROGRAMME
(ENVIRONMENTAL RIGHTS), CENTRE FOR ENVIRONMENT, HUMAN
RIGHTS AND DEVELOPMENT (CEHRD)

August 2009

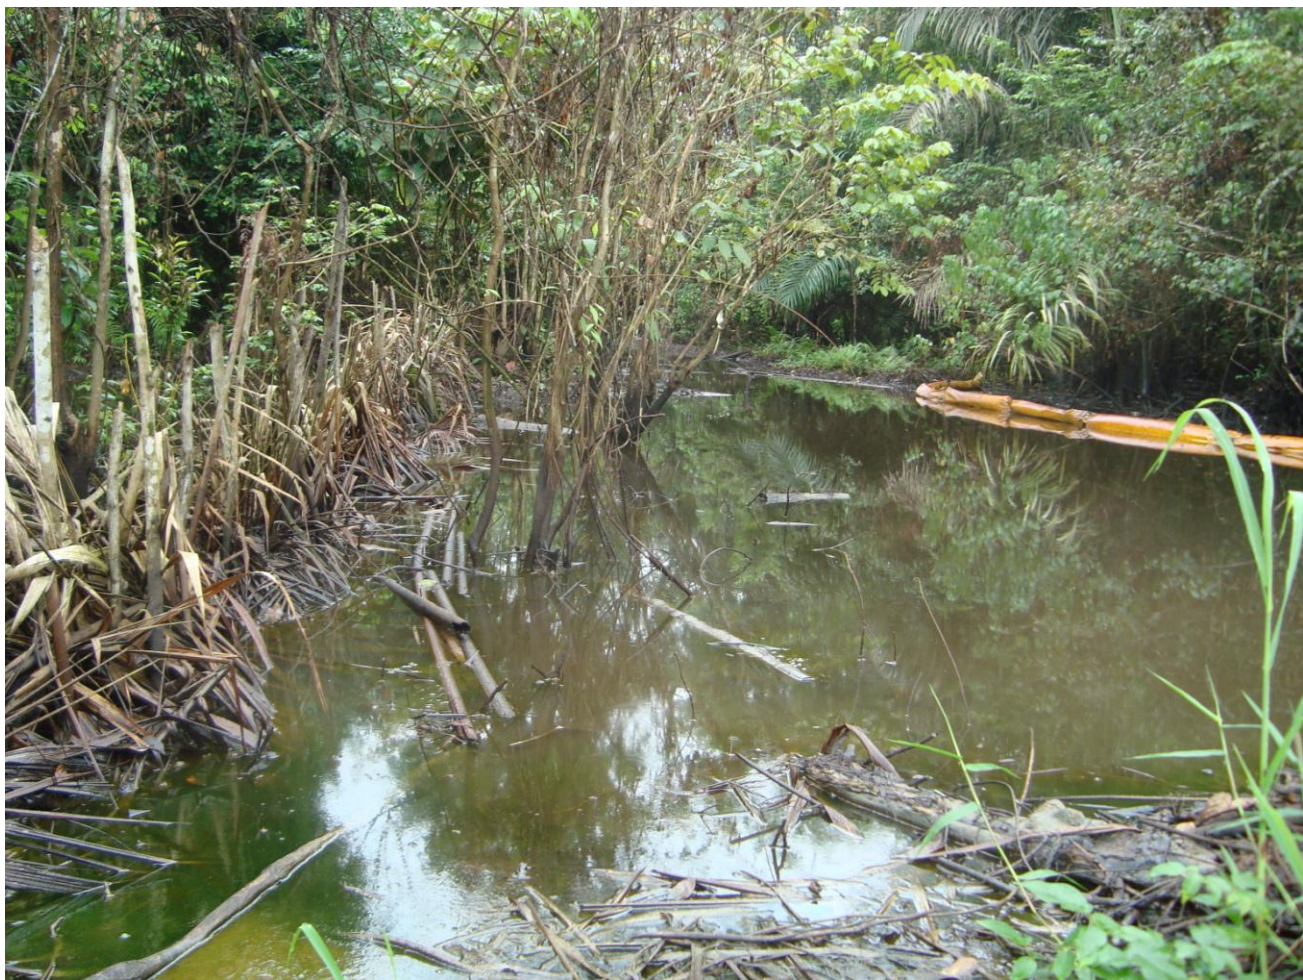
Plate 1: Parallel technologies; SPDC palm leaves boom + conventional boom at work.

Both spills (herein reported) are yet to be cleaned, if at all they would? As at the time of the visit, only quasi containment was ongoing. At the swamp site, storage (Geepee) tanks for mopped surface oil were seen ashore. On one side of the impacted flooded swamp, Foss boom is used to confine the oil. However, thick oil sleek is sighted behind the boom (the area intended to be foreclosed) which indicates that either the boom is inefficient for containment or contingency response was late or mostly likely due to leakages through spaces between palm fronds used to augment the boom. On the other flank of same floodplain, SPDC unsightly used palm fronds tied to pegged stakes for containment in place of conventional boom. CEHRD investigators were stunned by the sight of the ‘**SPDC “innovative” palm leaves boom**’. Of course, oil leaked through the leaves interspaces to the supposedly protected areas (see plates 1 and 2). *If containment is grossly inadequate and clean-up is doubtful, then rehabilitation and restoration of the site is not anticipated!*

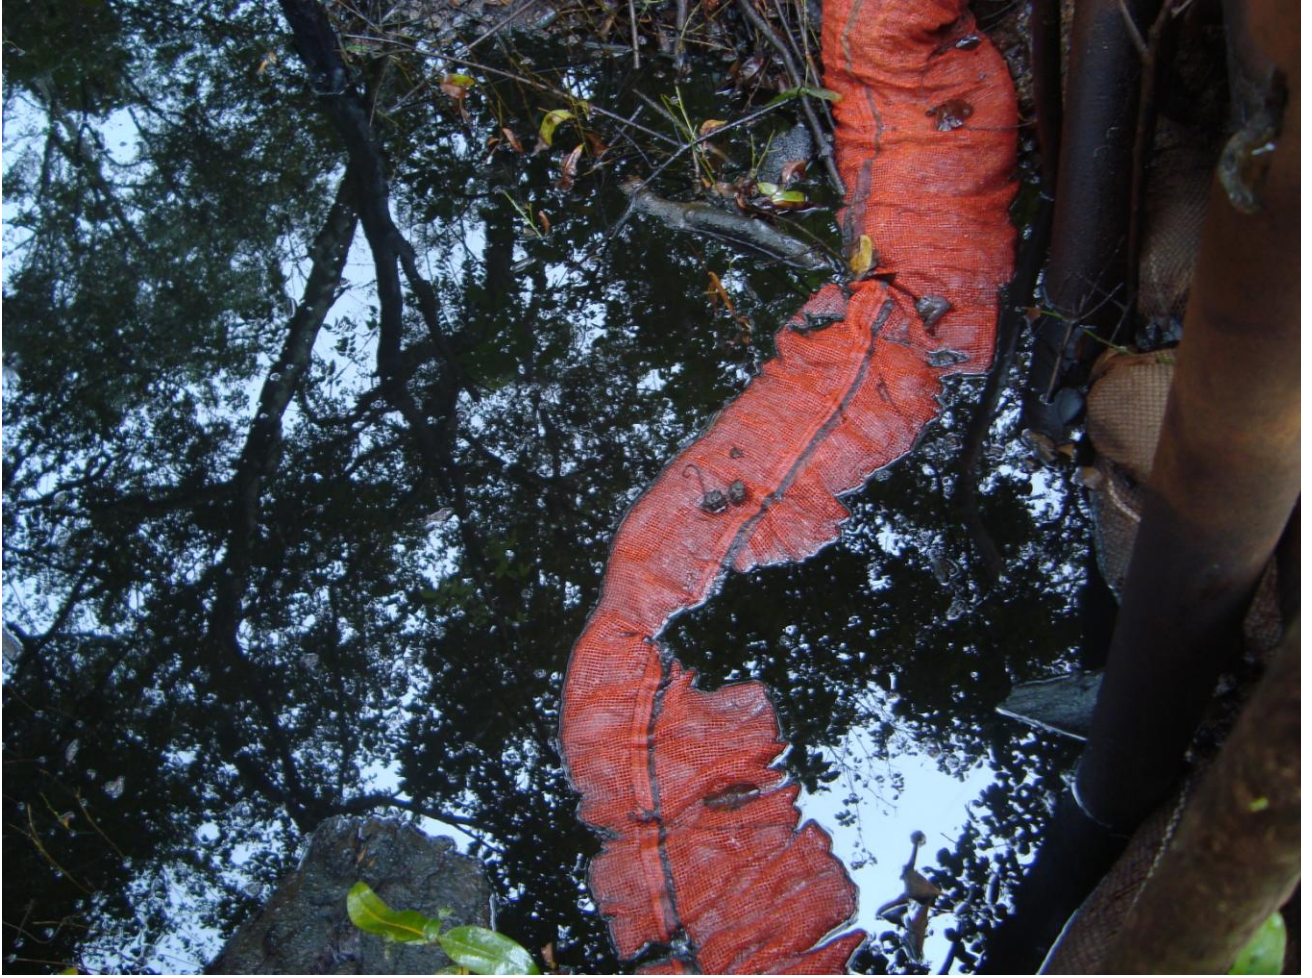
Plate 2: Sunken boom at Edagberi swamp.
